Coal Burner Condition and Estimated Remaining Life Evaluation

Final Report

Intermountain Generating Station

Energy & Environmental Research Corporation

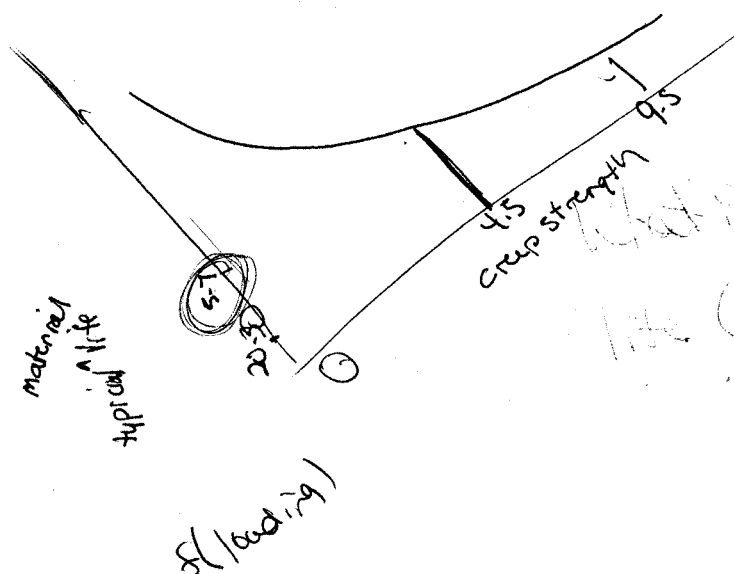
The majority of the stainless steel material on this burner is AISI 304. Although the maximum operating temperature (with regard to oxidation resistance) of this ^{particular} stainless steel is several hundred degrees higher, the creep strength is greatly reduced at elevated temperatures. Creep strength is the ability to resist permanent strain that increases as a function of time under stress. Depending on the source, the creep strength of AISI 304 stainless steel is approximately 9.5 KSI at 1350°F. Figure 3 illustrates the creep strength vs. temperature relationship for 304 stainless steel. For a long term installation such as this burner the 304 stainless material should be limited to 1150°F. *which has 9.5 KSI creep strength.* *Creep Strength vs. Boiler Life Curve*

What is the creep strength to life (years) relationship?
